Flood Control Project Maintenance
2019 Structure Summary Report
Overall Unit and Item Ratings

DWR Sacramento Maintenance Yard

Cache Creek Settling Basin Weir And Drainage Structure

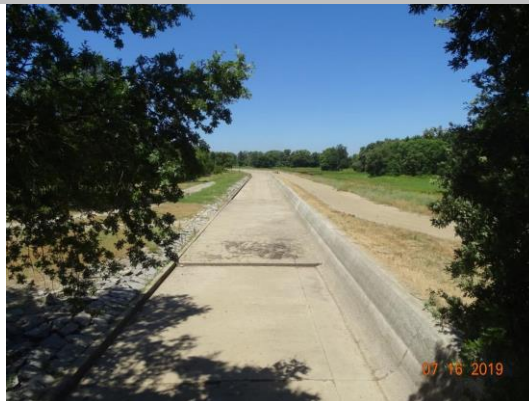
Photo 1 of 9 : ST_2019_NA0055_2_24_20190717_00021.jpg

View of the weir from the east abutment. Summer 2019.

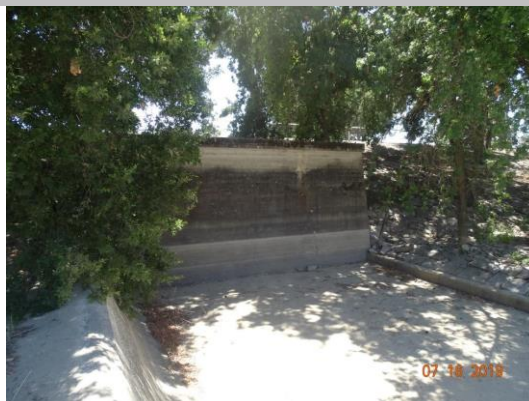
Photo 2 of 9 : ST_2019_NA0055_2_24_20190717_00022.jpg

View of the east abutment. Summer 2019.

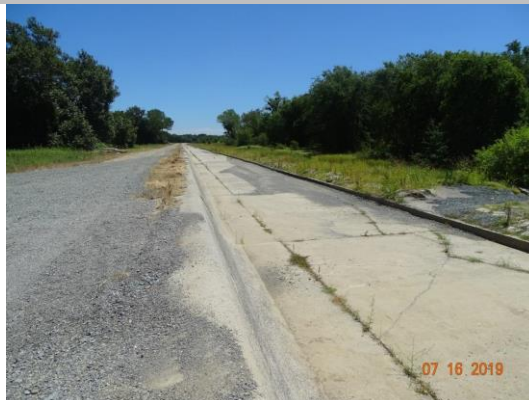
Photo 3 of 9 : ST_2019_NA0055_2_24_20190717_00023.jpg

View of the weir from the fish passage structure, facing east. Summer 2019.

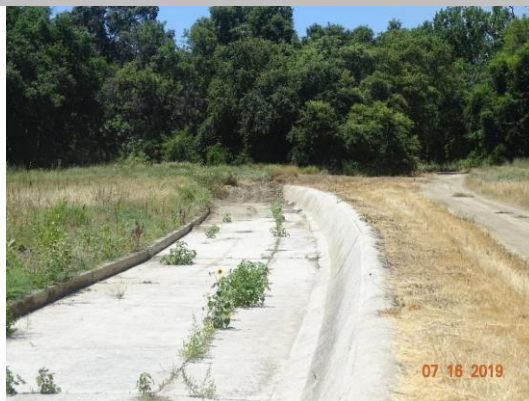
Photo 4 of 9 : ST_2019_NA0055_2_24_20190717_00024.jpg

View of the weir midpoint, facing southwest. Summer 2019.

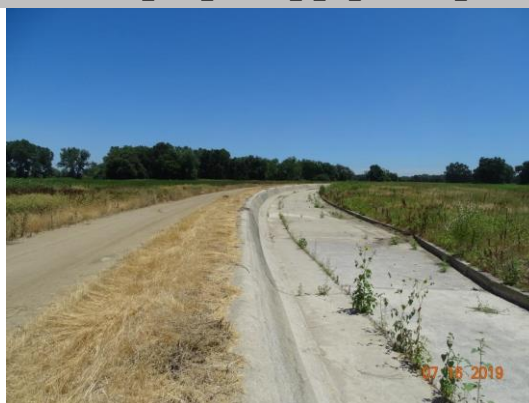
Photo 5 of 9 : ST_2019_NA0055_2_24_20190717_00025.jpg

View of the weir from the midpoint, facing northeast. Summer 2019.

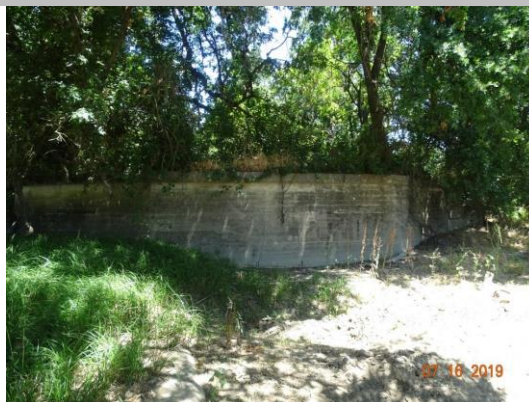
Photo 6 of 9 : ST_2019_NA0055_2_24_20190717_00026.jpg

View of the midpoint, facing northeast. Summer 2019.

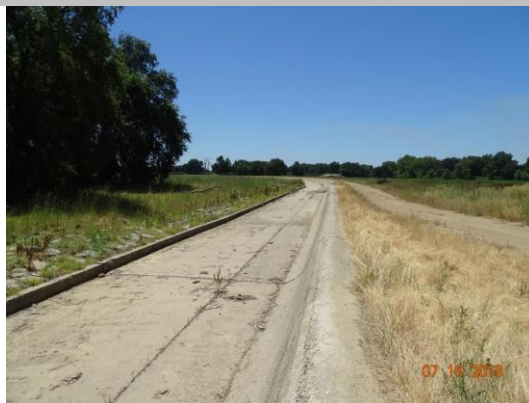
Photo 7 of 9 : ST_2019_NA0055_2_24_20190717_00027.jpg

View of the weir from the midpoint, facing southwest. Summer 2019.

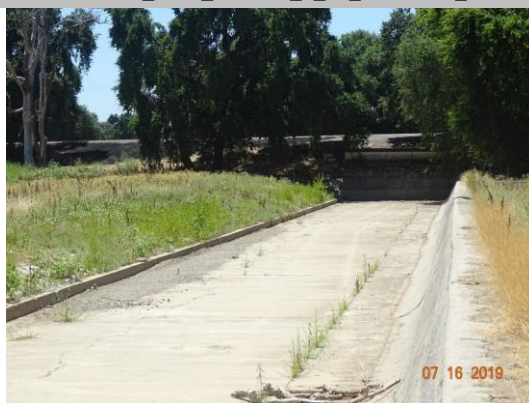
Photo 8 of 9 : ST_2019_NA0055_2_24_20190717_00028.jpg

View of the west abutment. Summer 2019.

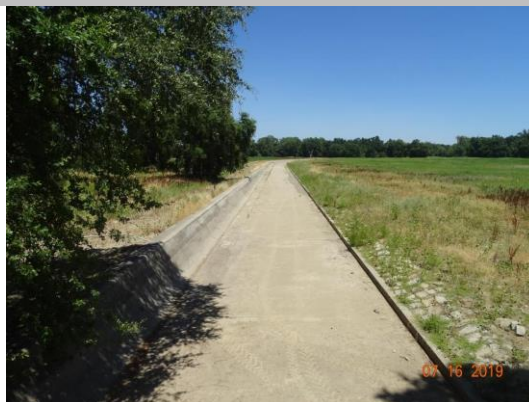
Photo 9 of 9 : ST_2019_NA0055_2_24_20190717_00029.jpg

View of the weir from the west abutment. Summer 2019.

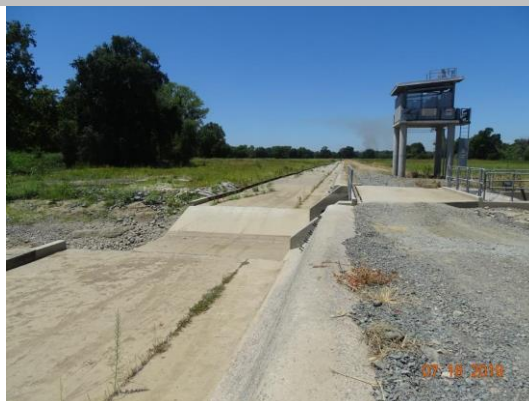
Photo 4 of 6 : ST_2019_NA0055_2_15_20190717_00031.jpg

LM Start	0.00	Rating **	A	Issue No.	15 (cont)
LM End	0.00	Issue Type +	Ma	Location *	CR
Category	Structures & Concrete Lined Channels	GPS Latitude/Longitude			
		Start		End	
Item	Concrete Surfaces	38.758880 °		38.764680 °	
		-121.665380 °		-121.635430 °	
DWR ID	DWR_NA0055_2_t_2012_15				
Action/Comments					
Inspector Comments: Large crack on the west weir abutment. Minor spalling on the weir wall. A new fish passageway within the weir was constructed.

View of the new fish passage and control structures. Summer 2019.

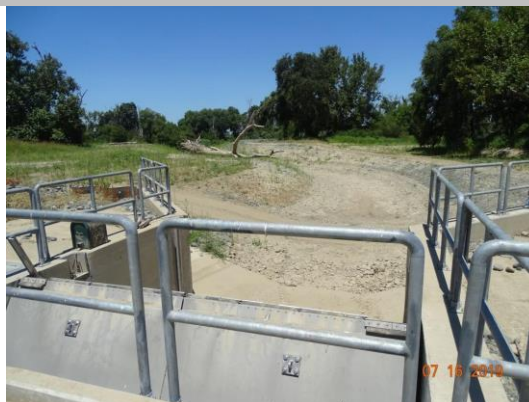
Photo 5 of 6 : ST_2019_NA0055_2_15_20190717_00032.jpg

View of the newly excavated back-channel, facing towards the Sacramento River. Summer 2019.

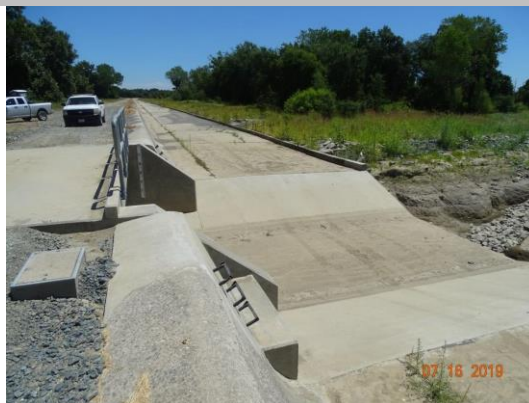
Photo 6 of 6 : ST_2019_NA0055_2_15_20190717_00034.jpg

LM Start	0.00	Rating **	A	Issue No.	15 (cont)
LM End	0.00	Issue Type +	Ma	Location *	CR
Category	Structures & Concrete Lined Channels	GPS Latitude/Longitude			
		Start		End	
Item	Concrete Surfaces	38.758880 °		38.764680 °	
		-121.665380 °		-121.635430 °	
DWR ID	DWR_NA0055_2_t_2012_15				
Action/Comments					
Inspector Comments: Large crack on the west weir abutment. Minor spalling on the weir wall. A new fish passageway within the weir was constructed.

View of the concrete transition from the weir to the fish passage structure. Summer 2019.

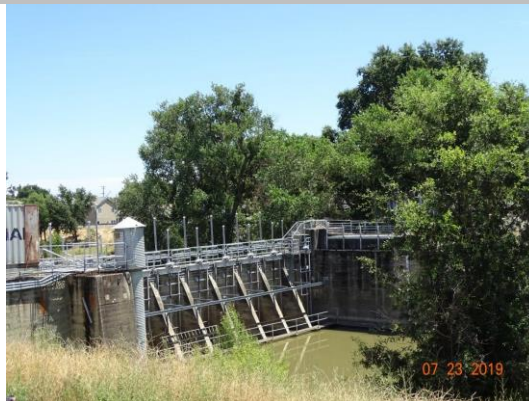
Photo 1 of 2 : ST_2019_NA0055_41_1_20190730_00012.jpg

View of the inlet side of the structure. Summer 2019.

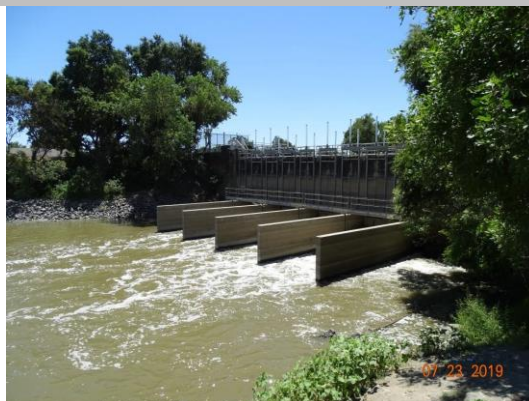
Photo 2 of 2 : ST_2019_NA0055_41_1_20190730_00013.jpg

View of the outlet side of the structure. Summer 2019.

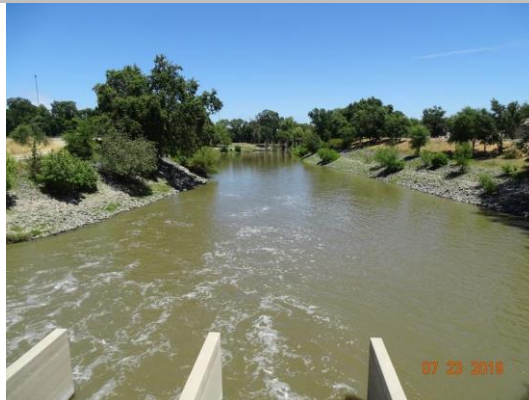
Photo 1 of 2 : ST_2019_NA0055_41_2_20190730_00016.jpg

LM Start	0.00	Rating **	A	Issue No.	2
LM End	0.00	Issue Type +	Ma	Location *	
Category	Structures & Concrete Lined Channels			GPS Latitude/Longitude	
				Start	End
Item	Vegetation & Obstructions			38.799560 °	38.799320 °
				-121.725530 °	-121.724850 °
DWR ID	DWR_NA0055_41_t_2012_2				
Action/Comments					
Inspector Comments: Minimal, scattered obstructions or vegetation. The flow is not impeded.

View of the channel looking downstream from the structure. Summer 2019.

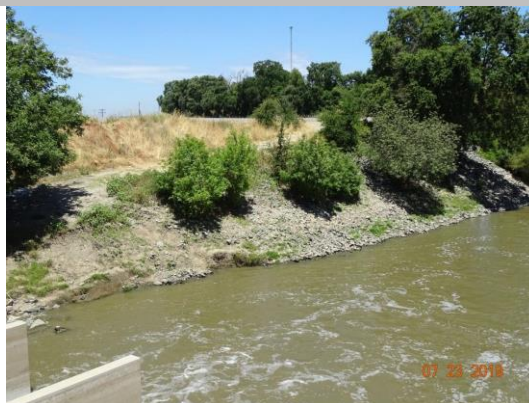
Photo 1 of 2 : ST_2019_NA0055_41_5_20190730_00017.jpg

LM Start	0.00	Rating **	A	Issue No.	5
LM End	0.00	Issue Type +	Ma	Location *	
Category	Structures & Concrete Lined Channels			GPS Latitude/Longitude	
				Start	End
Item	Revetments			38.799560 °	38.799320 °
				-121.725530 °	-121.724850 °
DWR ID	DWR_NA0055_41_t_2012_5				
Action/Comments					
Inspector Comments: Existing riprap protection is properly maintained and is undamaged. Riprap clearly visible.

View of riprap on the left bank. Summer 2019.

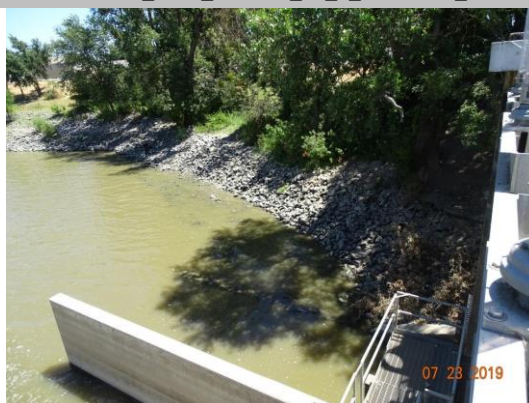
Photo 2 of 2 : ST_2019_NA0055_41_5_20190730_00018.jpg

View of the riprap on the right bank. Summer 2019.

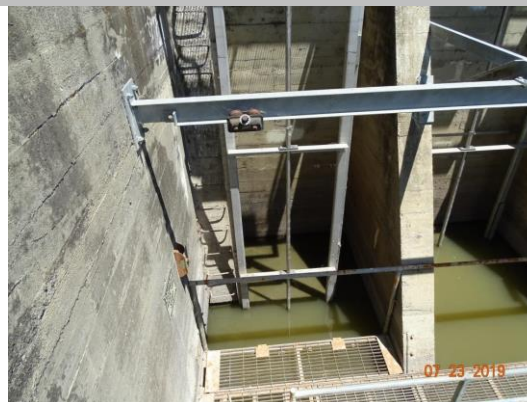
Photo 1 of 1 : ST_2019_NA0055_41_12_20190730_00019.jpg

LM Start	0.00	Rating **	A	Issue No.	12
LM End	0.00	Issue Type +	Ma	Location *	
Category	Structures & Concrete Lined Channels			GPS Latitude/Longitude	
				Start	End
Item	Sluice/Slide Gates			38.799560 °	38.799320 °
				-121.725530 °	-121.724850 °
DWR ID	DWR_NA0055_41_t_2012_12				
Action/Comments					
Inspector Comments: Gates open and close freely with minor leakage. Sill is free of sediment and other obstructions. Gates and lifters have been maintained.

View of the open slide gate at the inlet. Summer 2019.

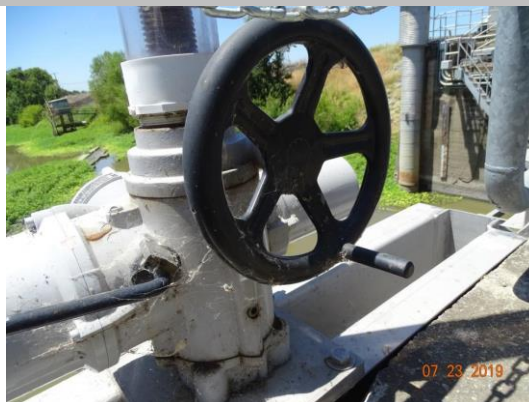
Photo 1 of 2 : ST_2019_NA0055_41_14_20190730_00020.jpg

LM Start	0.00	Rating **	A	Issue No.	14
LM End	0.00	Issue Type +	Ma	Location *	
Category	Structures & Concrete Lined Channels			GPS Latitude/Longitude	
				Start	End
Item	Manual Gate Operators			38.799560 °	38.799320 °
				-121.725530 °	-121.724850 °
DWR ID	DWR_NA0055_41_t_2012_14				
Action/Comments					
Inspector Comments: The manual gates are in good working condition.

View of the flap gate wheel. Summer 2019.

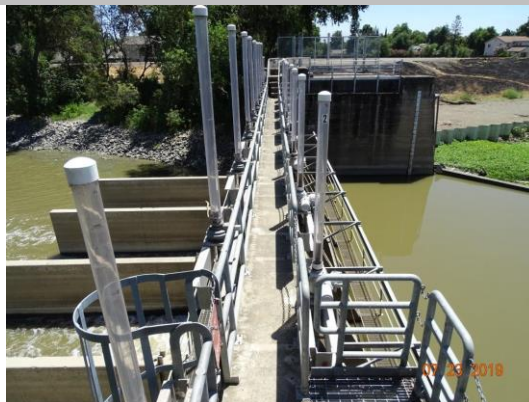
Photo 2 of 2 : ST_2019_NA0055_41_14_20190730_00021.jpg

View of the control structure to manually close the flap gates. Summer 2019.

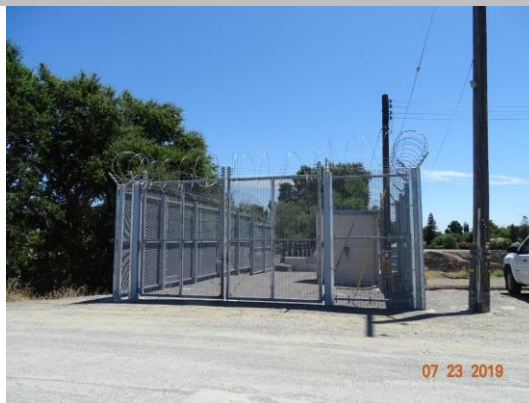
Photo 1 of 1 : ST_2019_NA0055_41_18_20190730_00023.jpg

LM Start	0.00	Rating **	A	Issue No.	18
LM End	0.00	Issue Type +	Ma	Location *	
Category	Structures & Concrete Lined Channels			GPS Latitude/Longitude	
				Start	End
Item	Security Fencing			38.799560 °	38.799320 °
				-121.725530 °	-121.724850 °
DWR ID	DWR_NA0055_41_t_2012_18				
Action/Comments					
Inspector Comments: Safety / security fencing is in good condition and provides protection against falling or unauthorized access. Gates open and close freely, locks are in place, and there is little corrosion on metal parts.

View of security fencing around structure. Summer 2019.

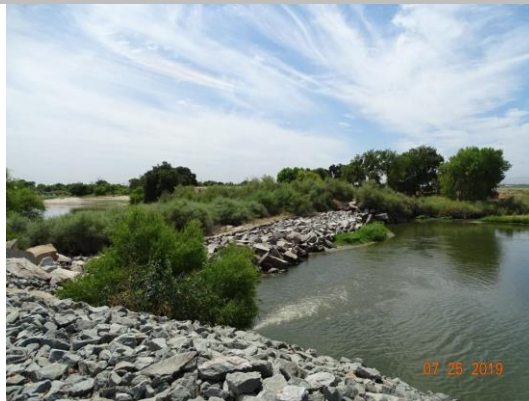
Photo 1 of 4 : ST_2019_NA0055_52_24_20190730_00016.jpg

View of Paradise Dam from the right bank of Paradise Cut. Summer 2019

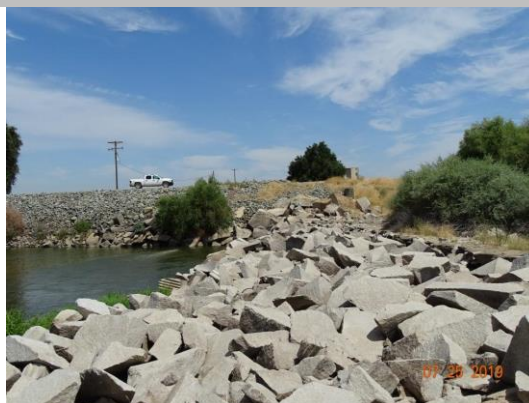
Photo 2 of 4 : ST_2019_NA0055_52_24_20190730_00017.jpg

View of Paradise Dam from left bank of Paradise Cut. Summer 2019

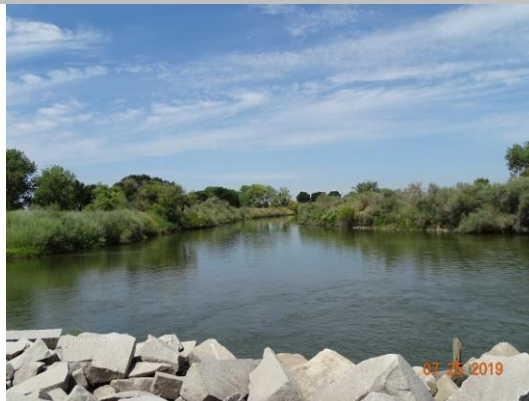
Photo 3 of 4 : ST_2019_NA0055_52_24_20190730_00018.jpg

View looking downstream at Paradise Cut. Summer 2019

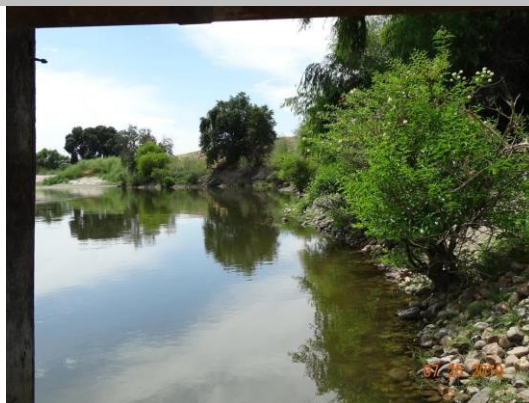
Photo 4 of 4 : ST_2019_NA0055_52_24_20190730_00019.jpg

View looking upstream of the San Joaquin river side of Paradise Dam.
Summer 2019

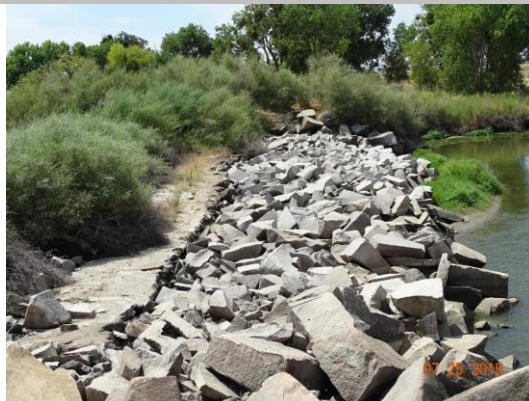
Photo 1 of 2 : ST_2019_NA0055_52_5_20190730_00015.jpg

LM Start	0.00	Rating **	A	Issue No.	5
LM End	0.00	Issue Type +	Ma	Location *	WS
Category	Structures & Concrete Lined Channels	GPS Latitude/Longitude			
		Start		End	
Item	Revetments	37.760584 °		37.760584 °	
		-121.309450 °		-121.309450 °	
DWR ID	DWR_NA0055_52_t_2017_5				
Action/Comments					
Inspector Comments: Existing riprap protection is properly maintained and is undamaged. Riprap clearly visible.

View of riprap protection on channel side of dam. Summer 2019

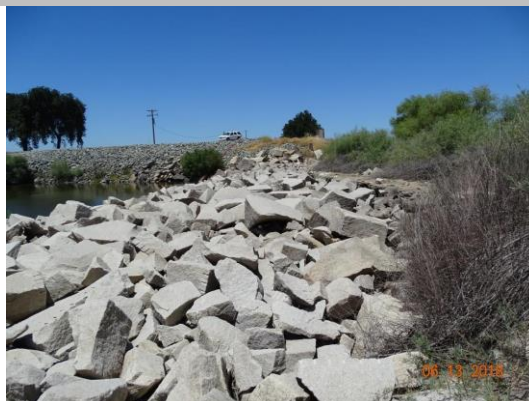
Photo 2 of 2 : ST_2019_NA0055_52_5_20190611_00004.jpg

View of riprap protection that is clearly visible. Summer 2018

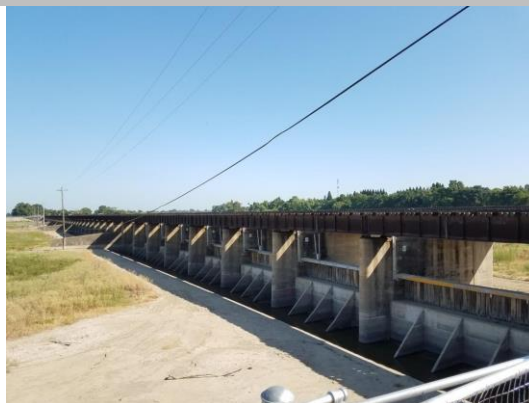
Photo 1 of 4 : ST_2019_NA0055_1_24_20190703_00021.jpg

View of the weir outlet from the south end. Summer 2019.

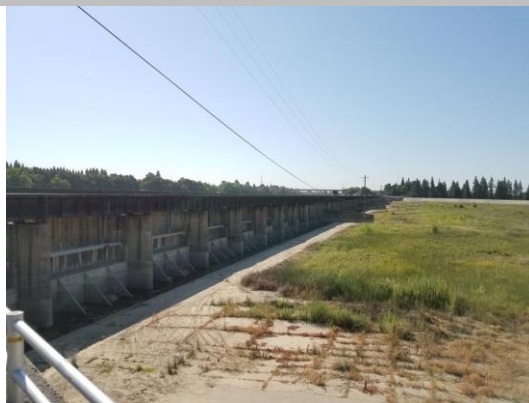
Photo 2 of 4 : ST_2019_NA0055_1_24_20190703_00022.jpg

View of the weir outlet from the north end. Summer 2019.

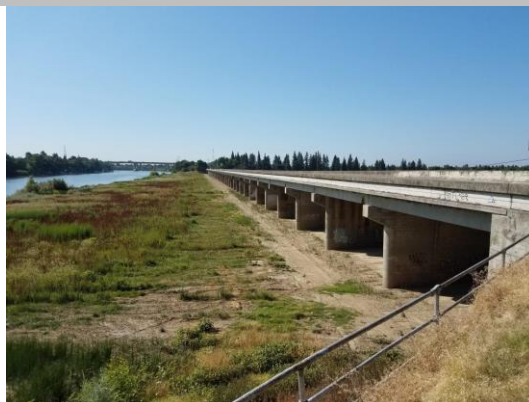
Photo 3 of 4 : ST_2019_NA0055_1_24_20190703_00023.jpg

View of the weir inlet from the north end. Summer 2019.

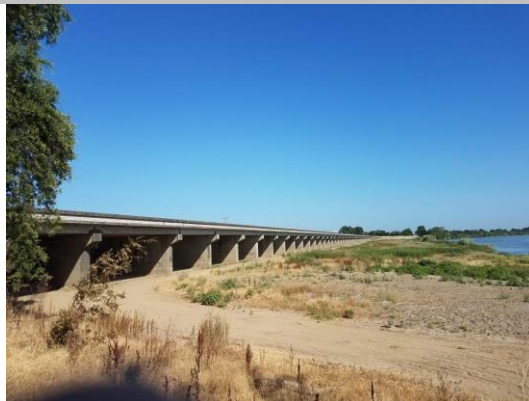
Photo 4 of 4 : ST_2019_NA0055_1_24_20190703_00024.jpg

View of the weir inlet from the south end. Summer 2019.
